Subject: Annual Inspection Report
Vaiden Field Airport (A08)

ANNUAL INSPECTION REPORT

**VAIDEN FIELD AIRPORT
MARION, ALABAMA**

Alabama Department of Transportation Aeronautics Bureau—Annual Airport Inspection Report

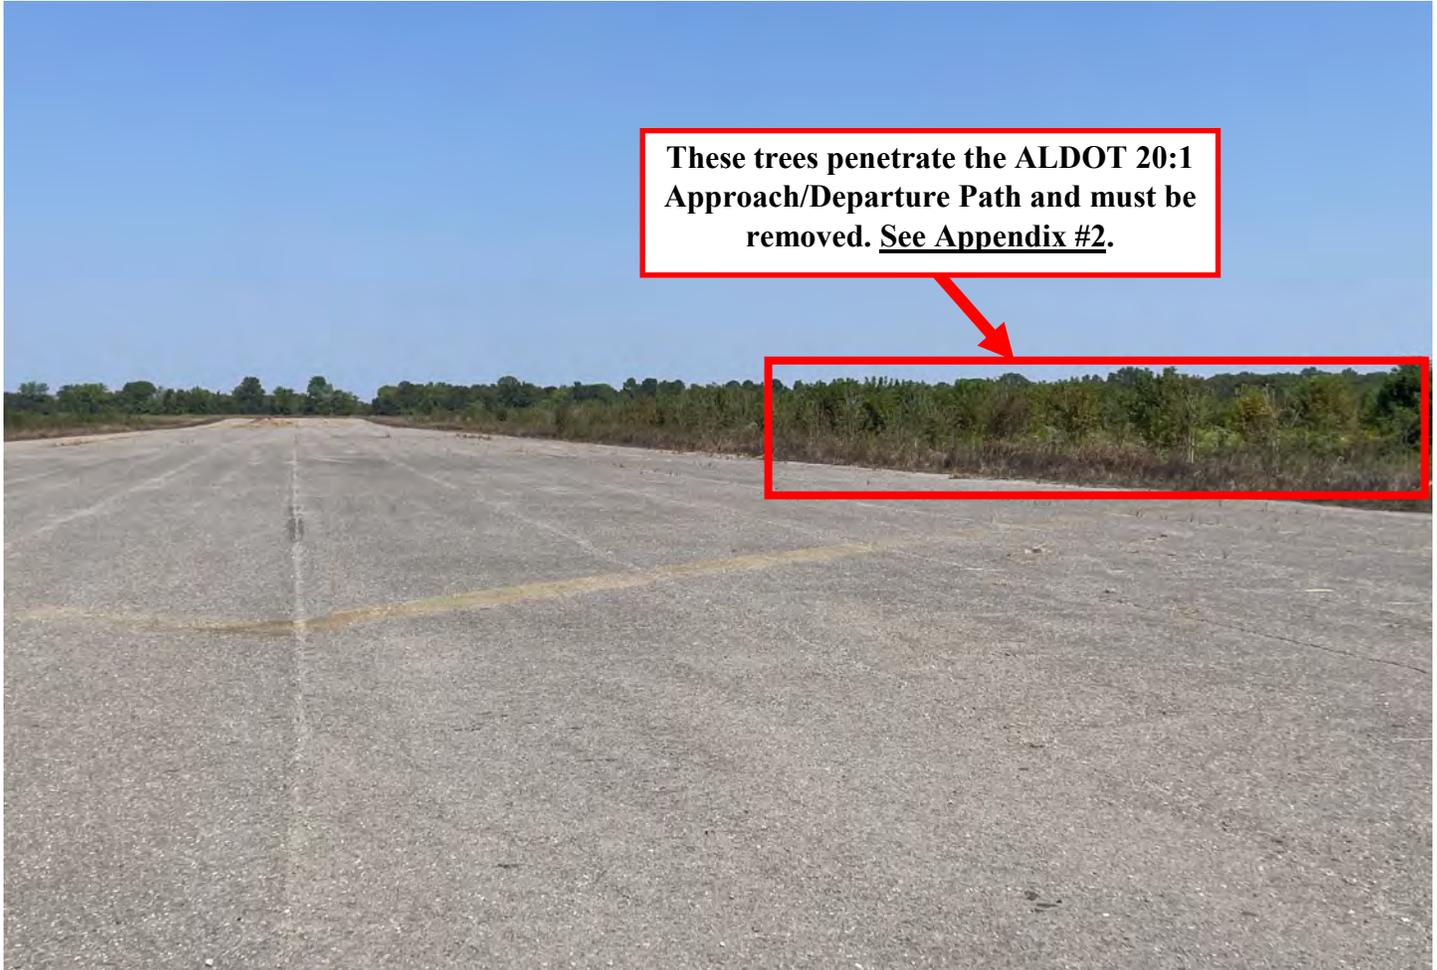
Approach and Departure Paths—Runway 16

| Aeronautics Administrative Code | Inspection Results | Corrective Action | Notes |
|--|--|--|---|
| Approach & Departure Paths Administrative Code 450-9-1-.12 (1) | <i>Violation</i> | Remove or mitigate all trees that penetrate the ALDOT 20:1 Approach/Departure Path. <i>Note:</i> The trees found can be checked by a licensed surveyor to determine if they are obstructions. | Obstructions were detected inside the ALDOT 20:1 Approach/Departure Path. See Appendix #2. |

VIOLATION: There were obstructions detected inside the ALDOT 20:1 Approach/Departure Path of Runway 16. These trees must be removed. **See Appendix #2.**

Note: Obstructions identified are representative and may not include all existing obstructions. These trees can also be checked by a licensed surveyor to determine if they are obstructions.

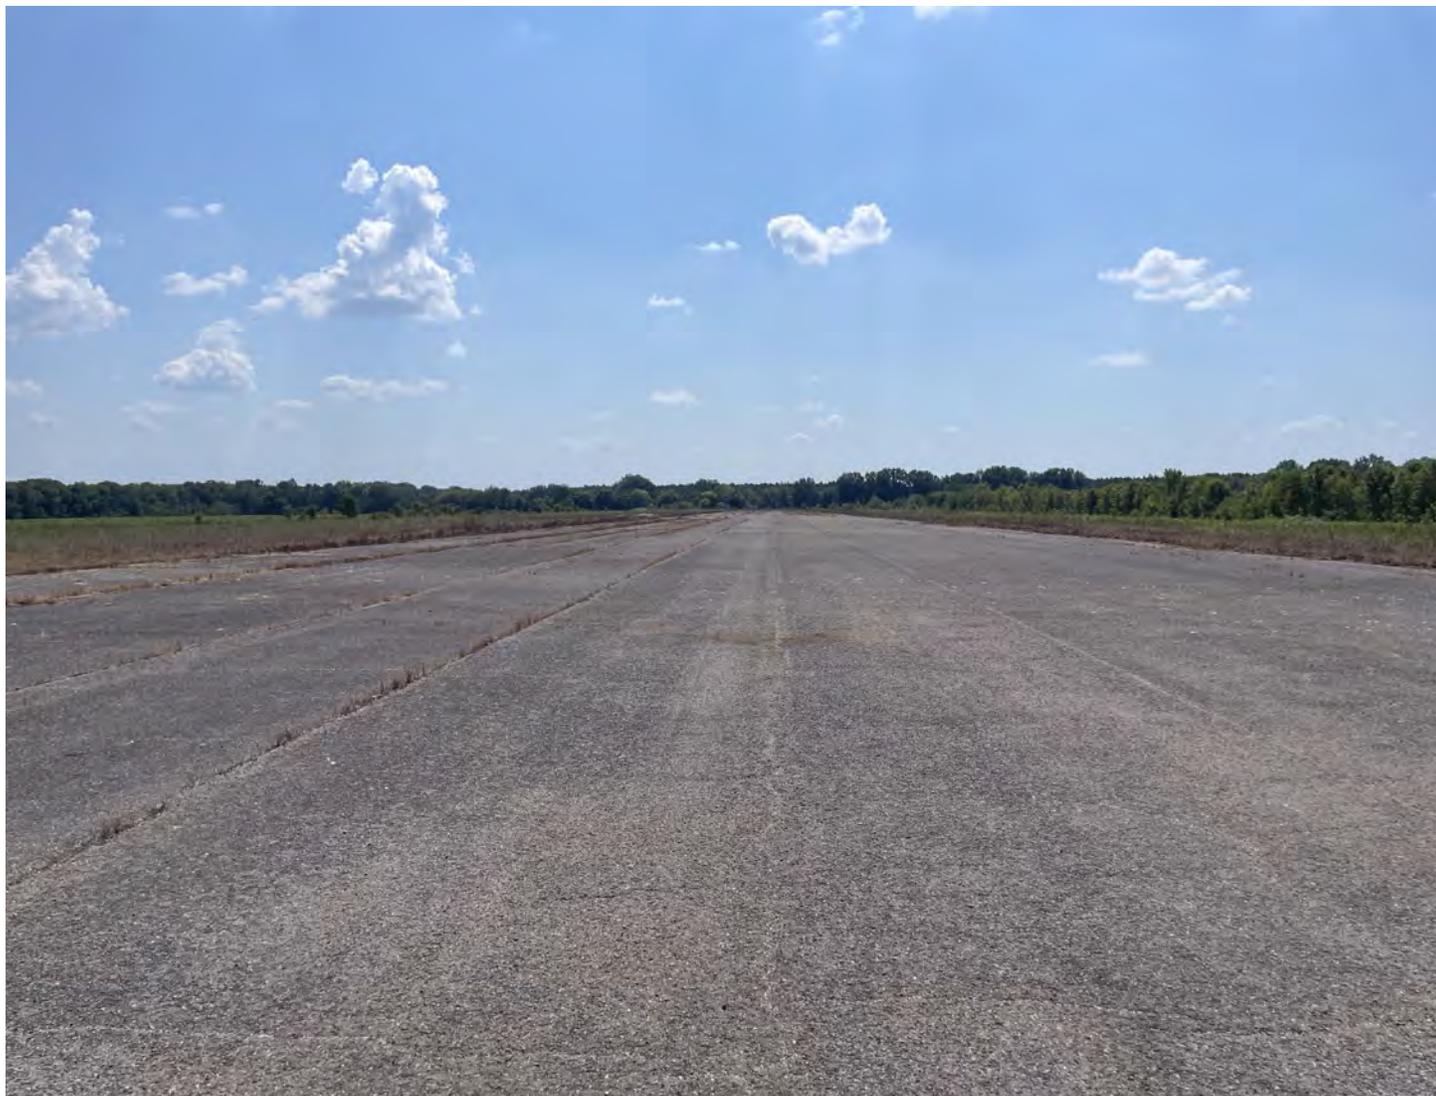
Approach and Departure Paths—Runway 34

There were no obstructions detected inside the ALDOT 20:1 Approach/Departure Path of Runway 34.

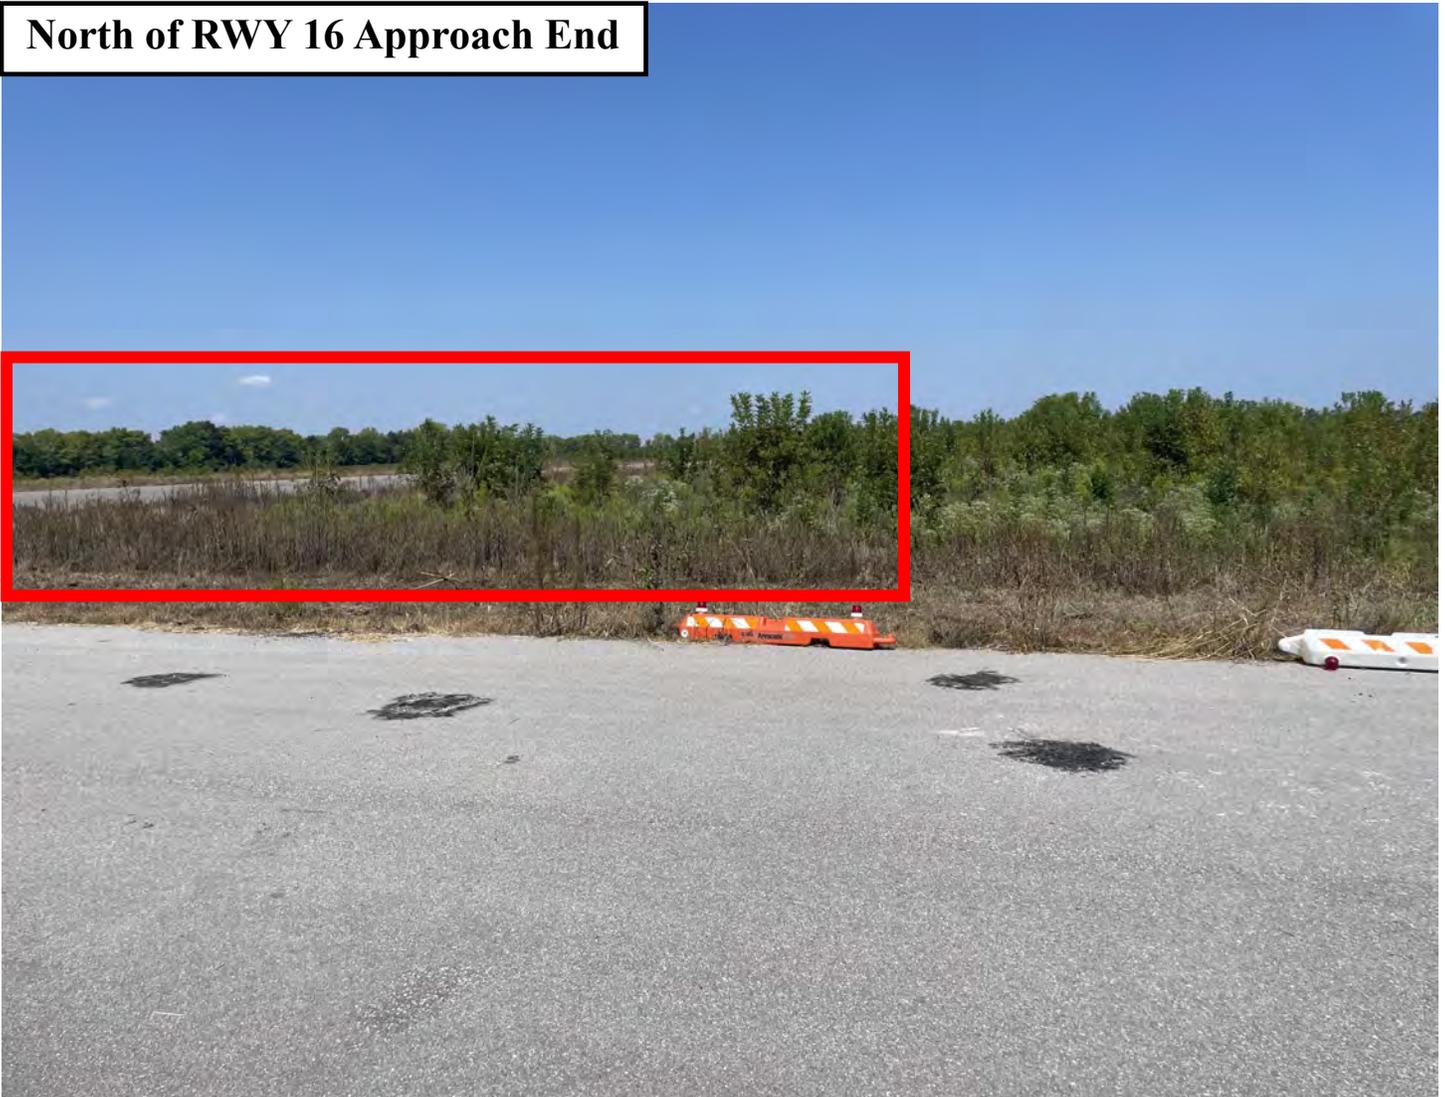
North of RWY 16 Approach End

| Aeronautics Administrative Code | Inspection Results | Corrective Action | Notes |
|--|--|--|---|
| Primary Surface Administrative Code 450-9-1-.12 (2) | <i>Violation</i> | Please clear all trees, bushes and tall grass from this area. See Appendix #2 and page #4. | Significant vegetation exists within the Primary Surface north of the Runway 16 approach end. |

VIOLATION: The Primary Surface **DOES NOT MEET** state licensing standards. Significant vegetation exists within the boundaries of the Primary Surface north of the Runway 16 approach end. Please clear the Primary Surface of all trees, bushes and tall grass. See **Appendix #2** for additional information.

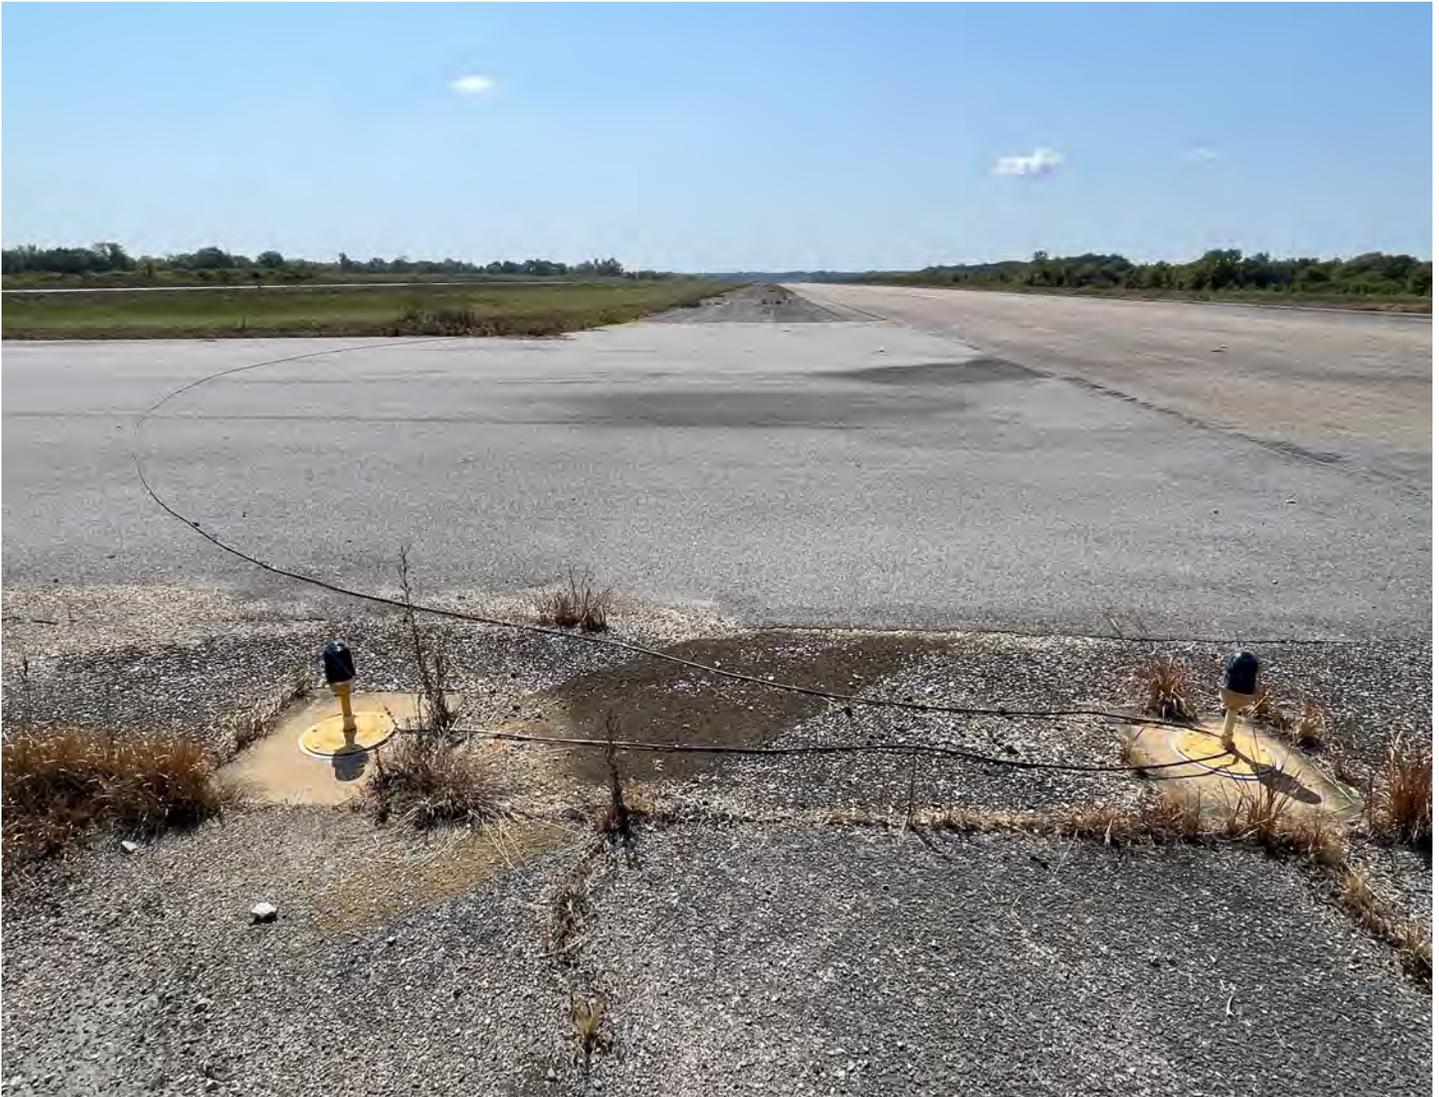
| Aeronautics Administrative Code | Inspection Results | Corrective Action | Notes |
|--|--|--|---|
| Runway Safety Area Administrative Code 450-9-1-.12 (3) | <i>Violation</i> | Please remove the cable connected to a threshold light from the Safety Area. | A cable on the Runway 16 approach end is inside the Runway Safety Area. See page #5. |

VIOLATION: The Runway Safety Area **DOES NOT MEET** state licensing standards. A cable connected to a threshold light on the Runway 16 approach end is inside the Runway Safety Area and should be removed immediately.

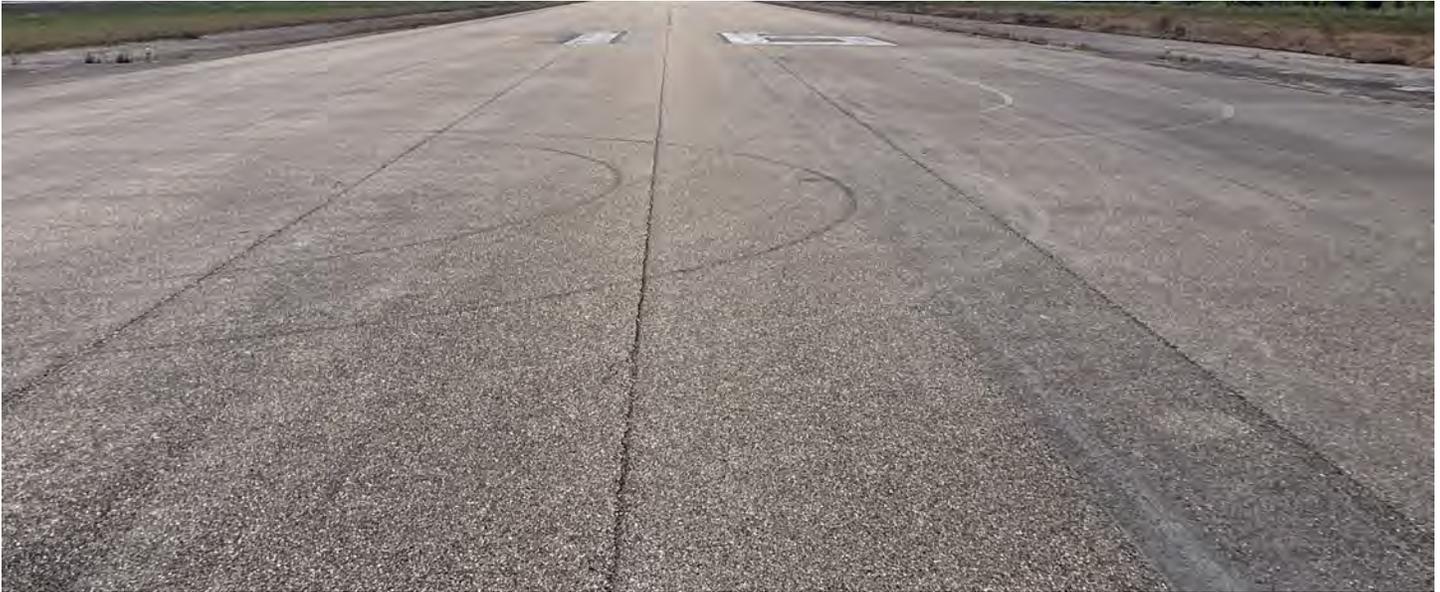
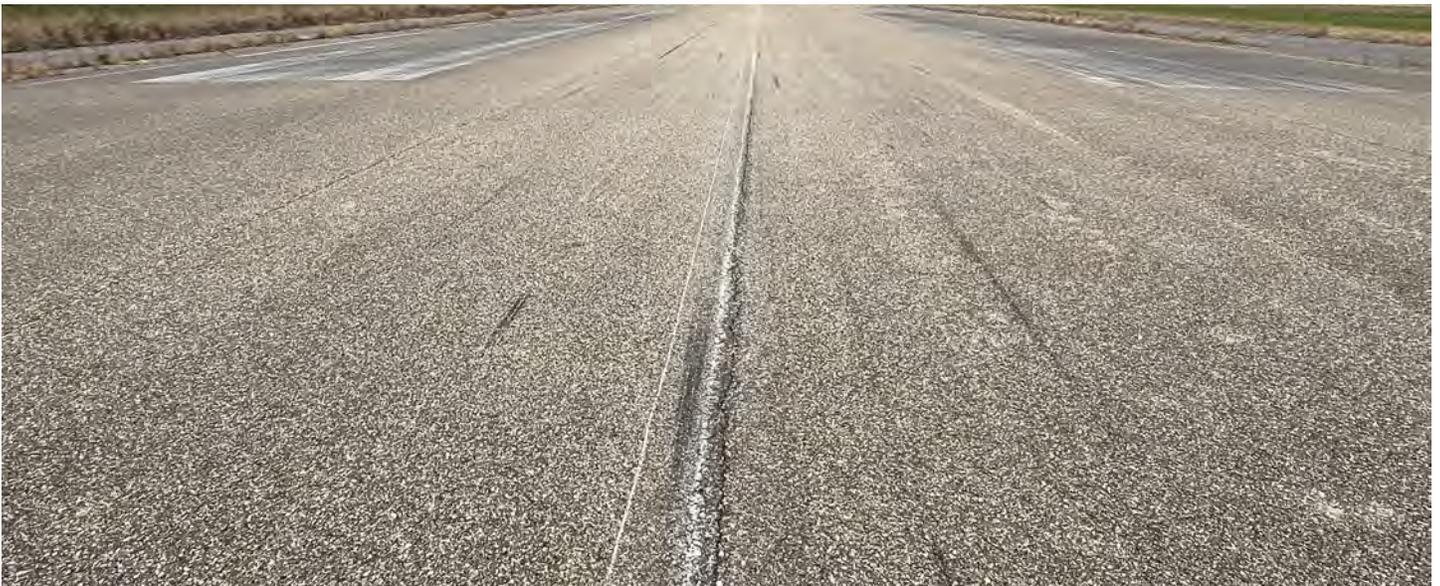
Airport Markings—Runway

| Aeronautics Administrative Code | Inspection Results | Corrective Action | Notes |
|--|--|--|---|
| Airport Markings Administrative Code 450-9-1-.12 (4) | <i>Violation</i> | Repaint runway markings in accordance with FAA AC 150/5340-1M. | Some runway markings are almost entirely faded. See page #6. |

VIOLATION: The runway designator markings are in **FAIR** condition. However, all other runway markings, including the centerline, side-stripe and threshold markings, are **almost entirely faded** and in **VERY POOR** condition. Please repaint these markings in accordance with FAA AC 150/5340-1M.

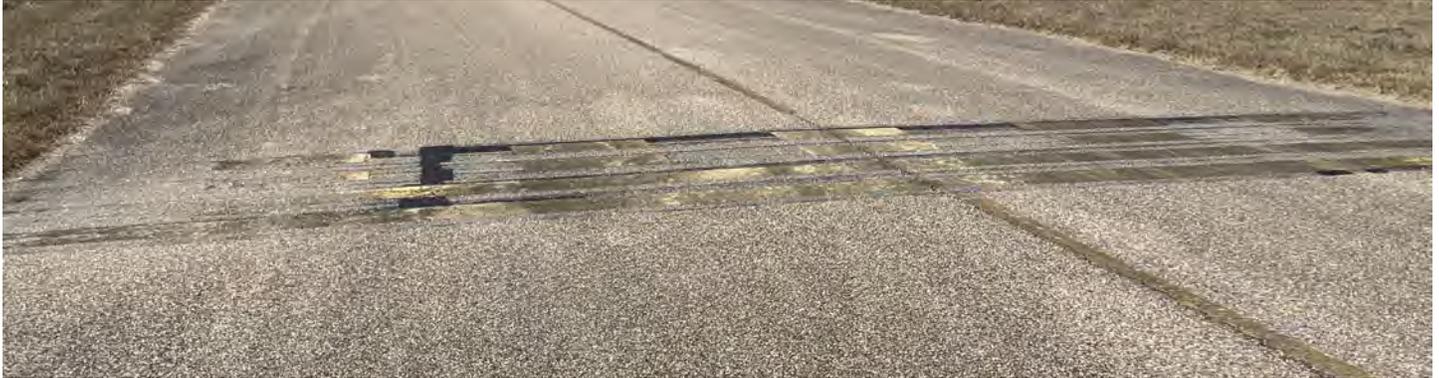
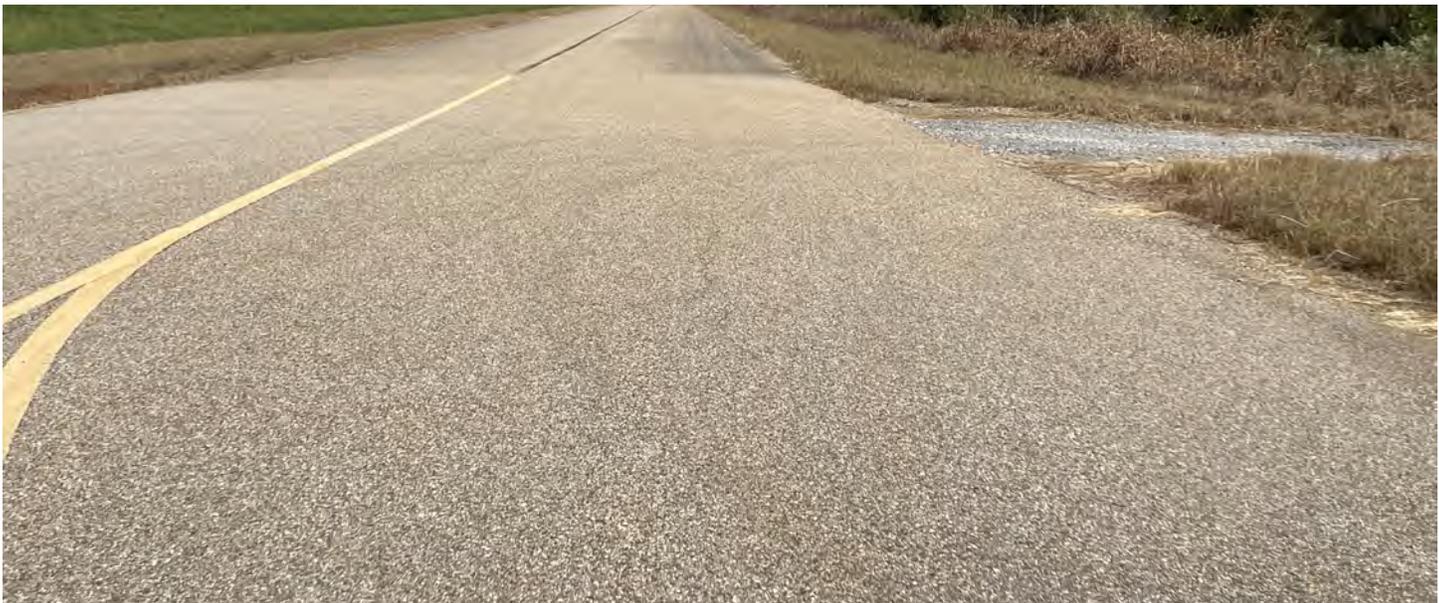
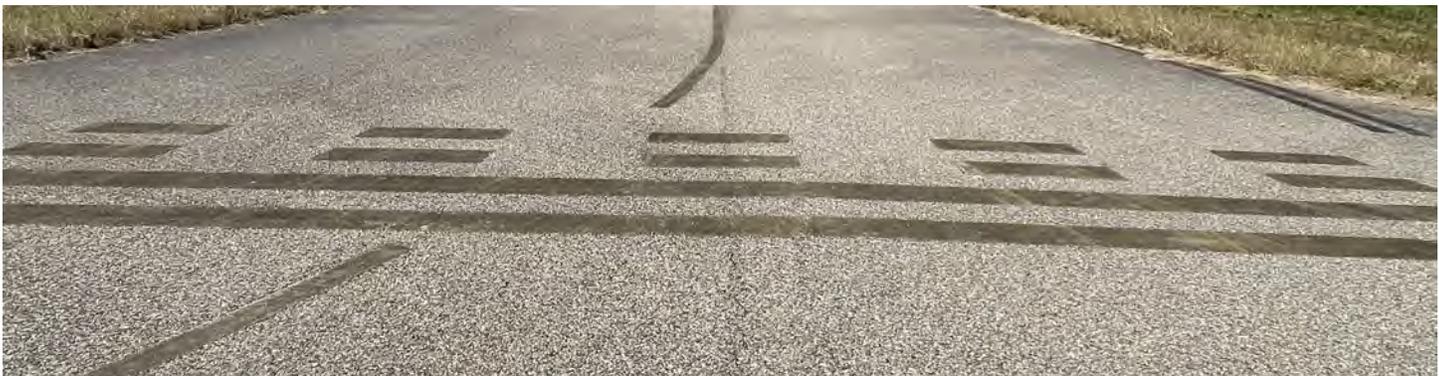
Airport Markings—Taxiway

MAINTENANCE: The taxiway markings range from **FAIR** to **POOR** condition. Most taxiway centerline and hold short markings are faded or almost entirely faded in some instances. Markings in poor condition should be repainted in accordance with FAA AC 150/5340-1M.

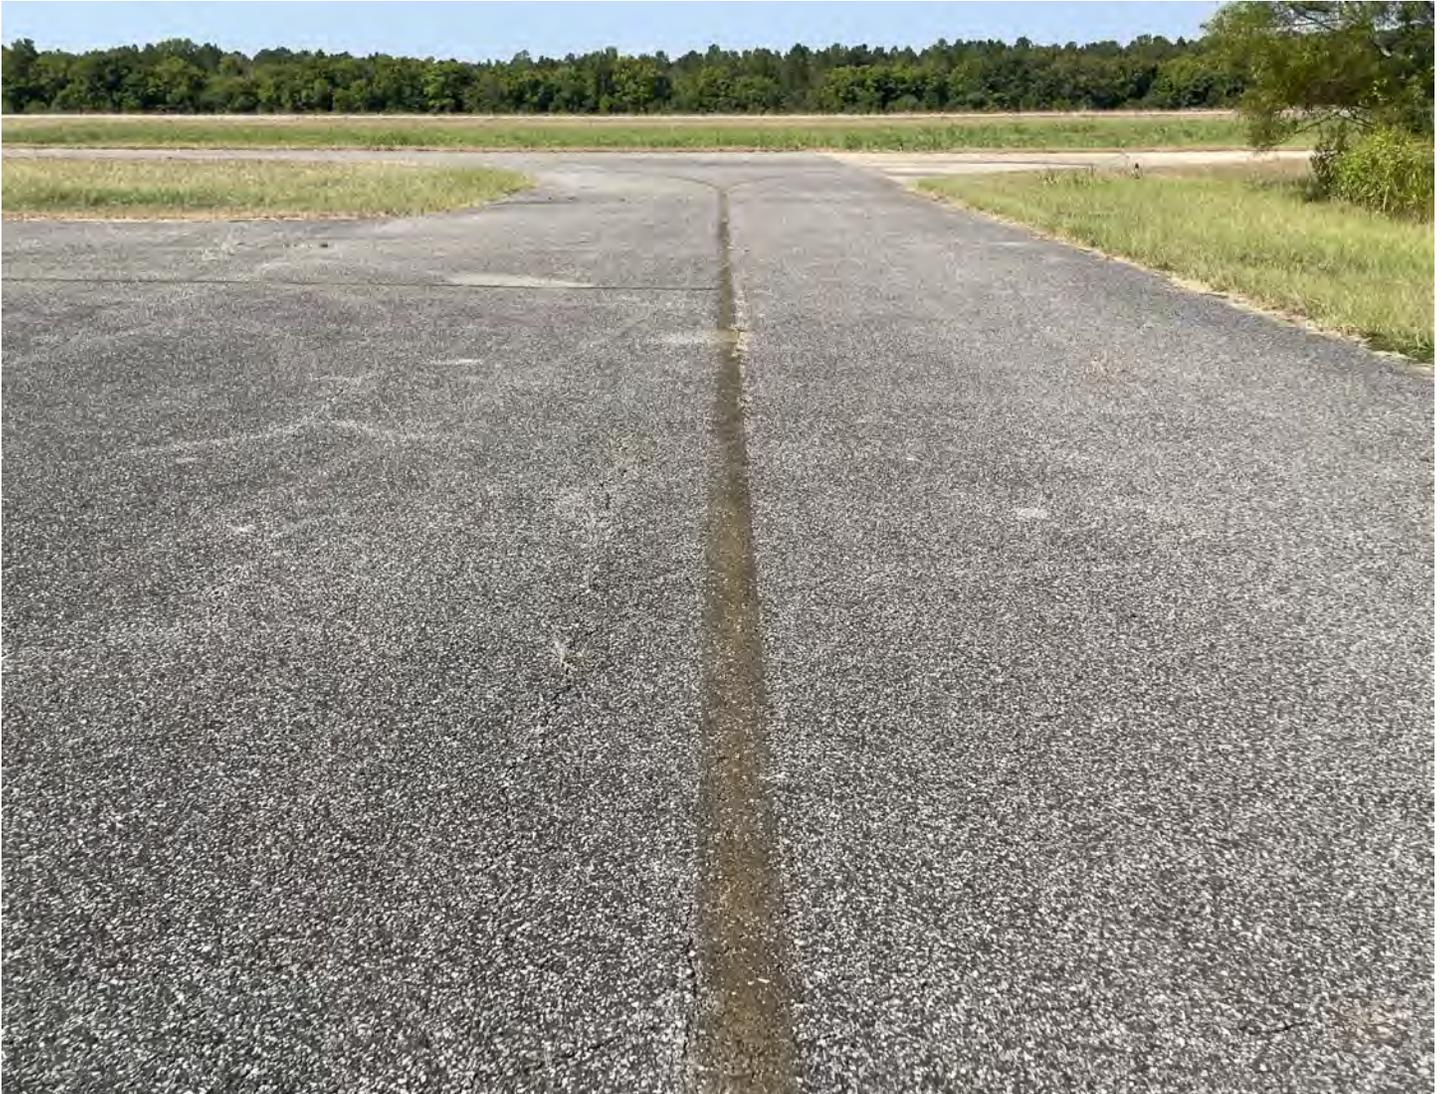
Airport Markings—Apron

MAINTENANCE: The apron markings are faded and in **POOR** condition. The apron markings should be repainted in accordance with FAA AC 150/5340-1M.

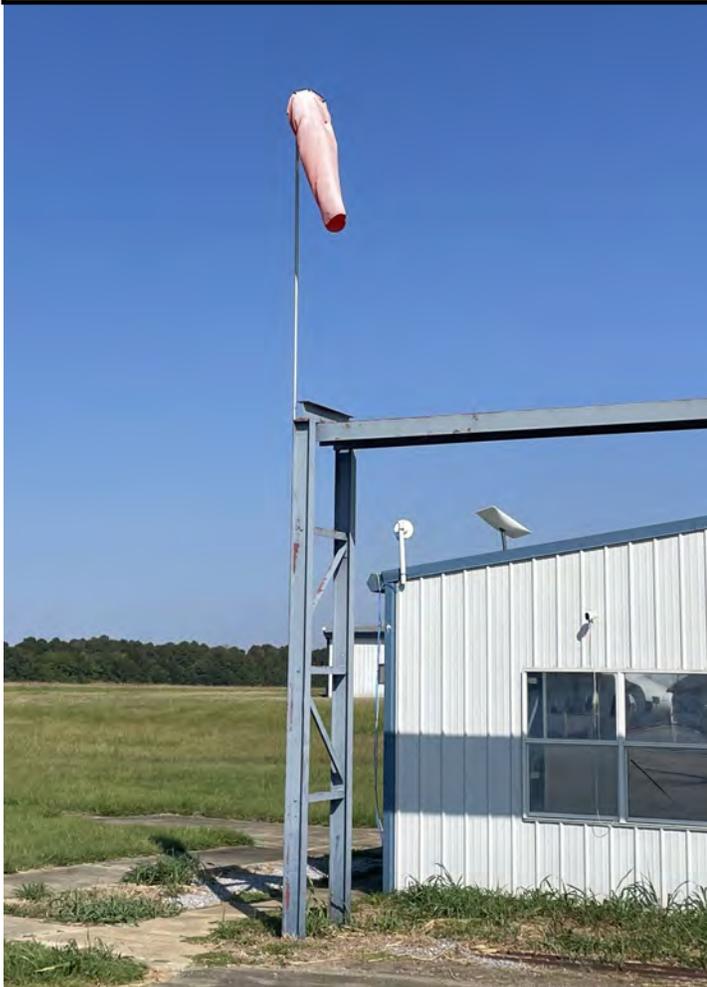
| Aeronautics Administrative Code | Inspection Results | Corrective Action | Notes |
|--|--|--|---|
| Wind Direction Indicator Administrative Code 450-9-1-.12 (5) | <i>Violation</i> | Please install a wind direction indicator that is in a visible area free of obstructions. | The existing wind direction indicator does not comply with state licensing standards. See page #9. |

Existing wind direction indicator—not compliant due to its location.

VIOLATION: Although there is a wind direction indicator at the main apron hangar, it **DOES NOT MEET** state licensing standards as it is not located in an area that is visible from any point on the airfield or free of wind obstructions. The airport previously had a wind direction indicator that was compliant with state standards in the field to the west of the runway, shown in a picture above. Please replace the wind direction indicator that was in this location or install a new one in an area that is highly visible and free of wind obstructions.

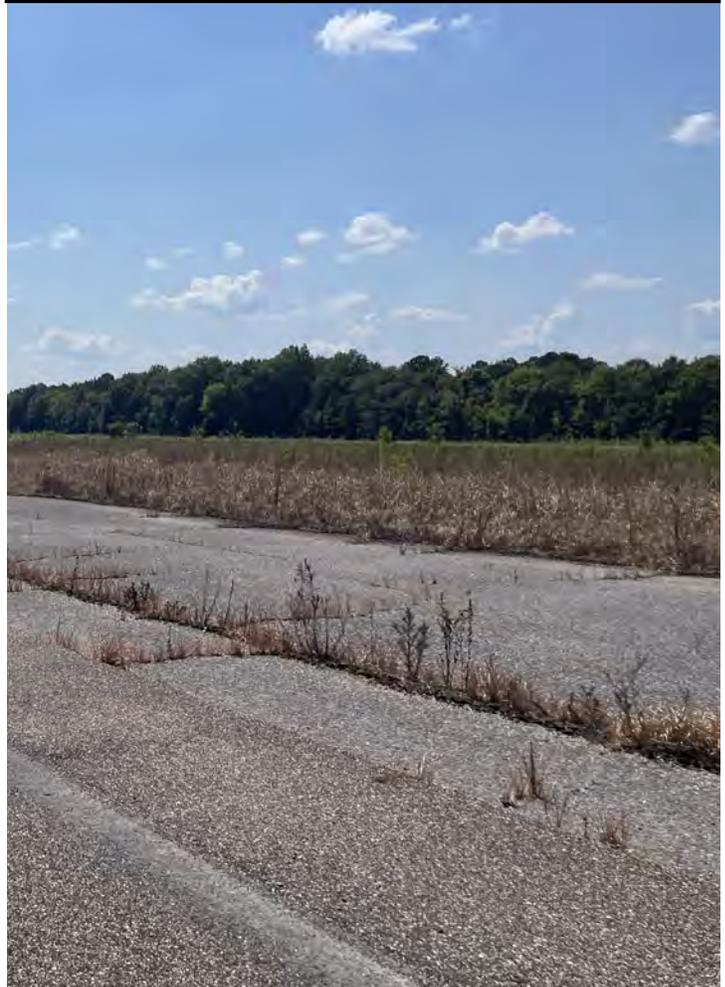
Previous location of compliant wind direction indicator.

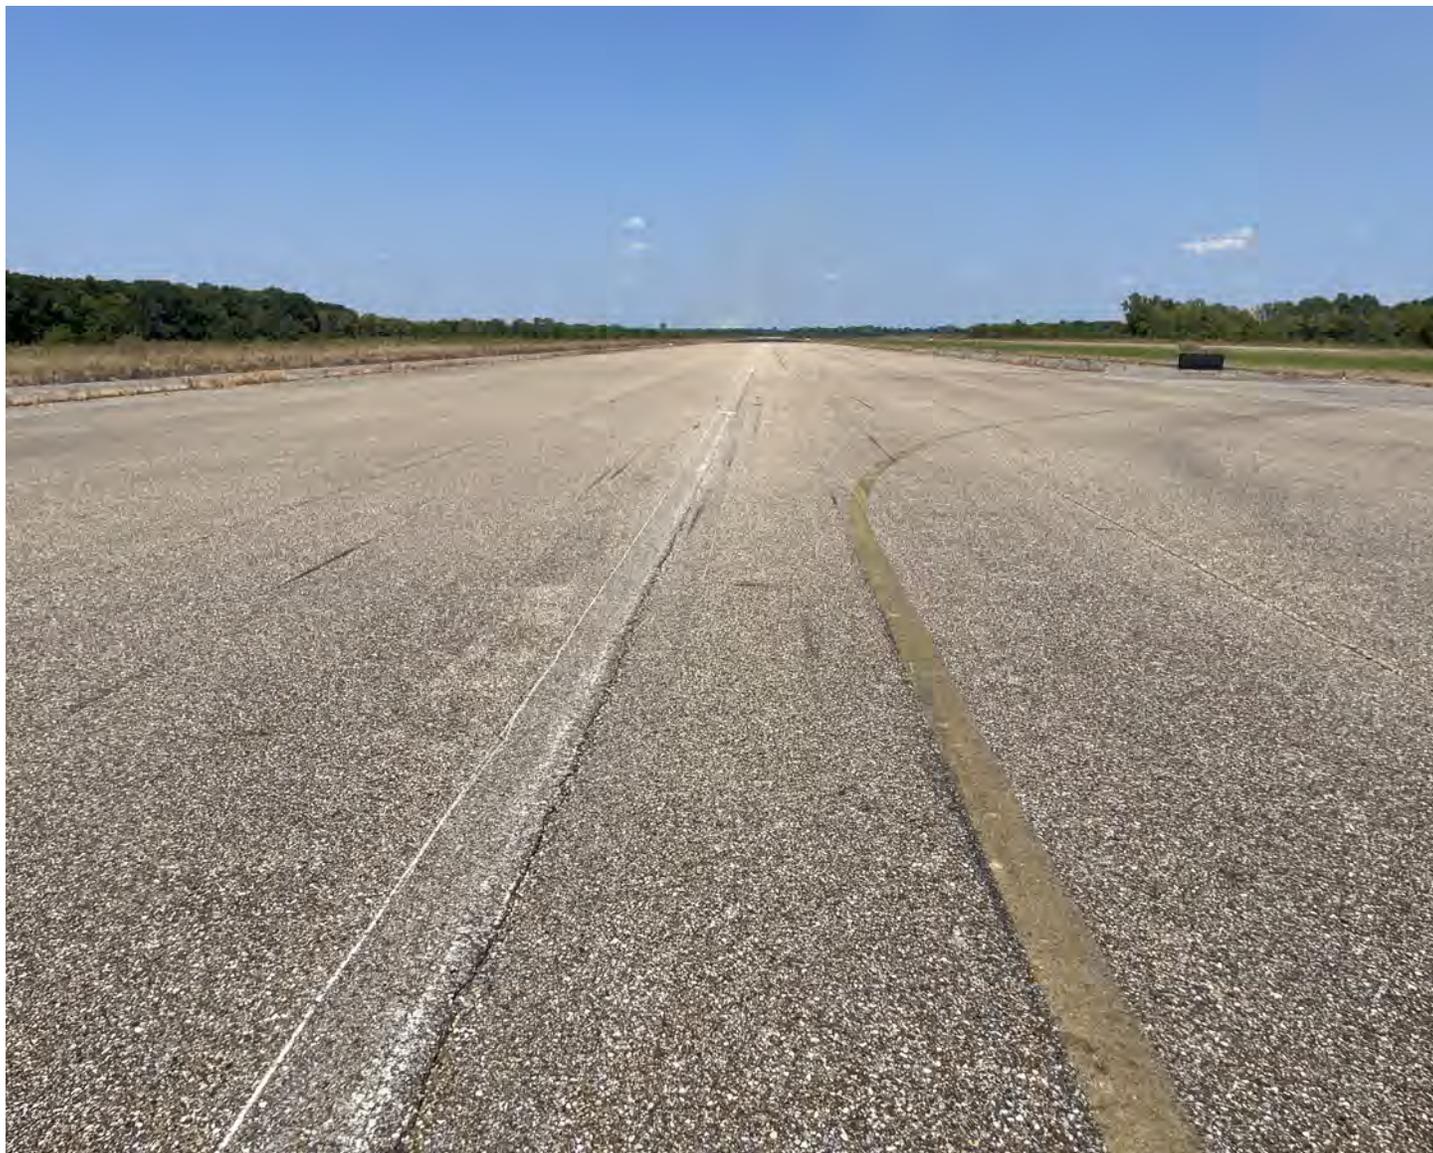
Runway, Taxiway and Apron Conditions—RUNWAY

The runway surface is in **FAIR** overall condition.

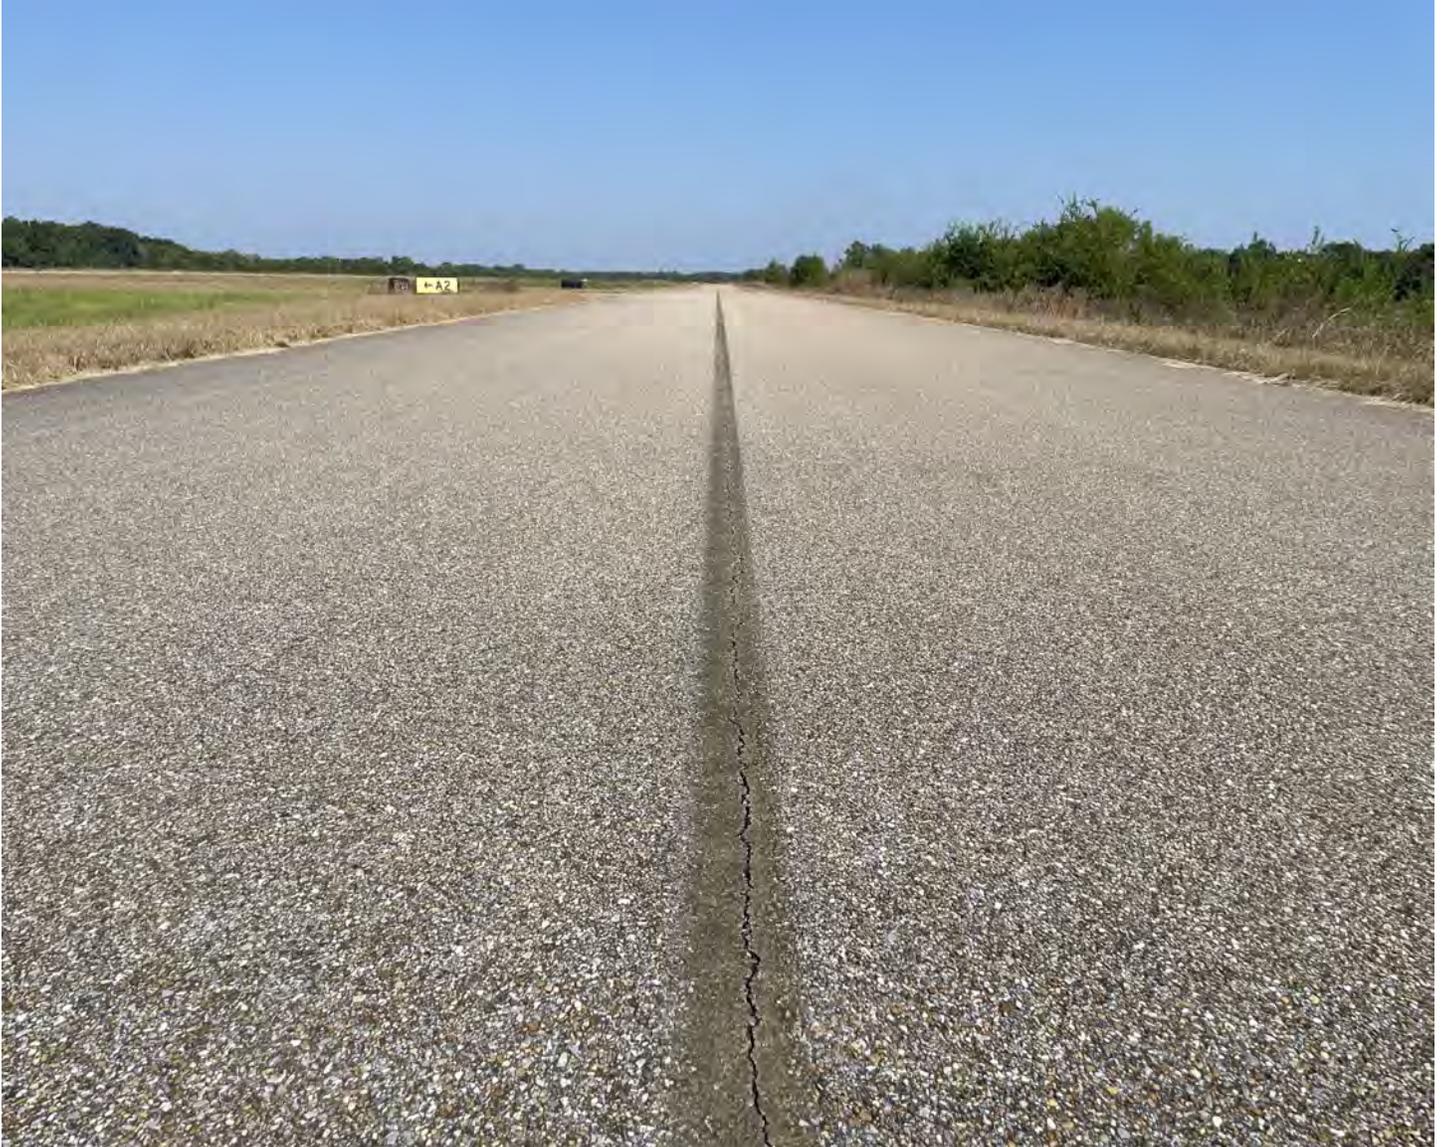
Runway, Taxiway and Apron Conditions—TAXIWAY

The taxiway surface is in **FAIR** overall condition.

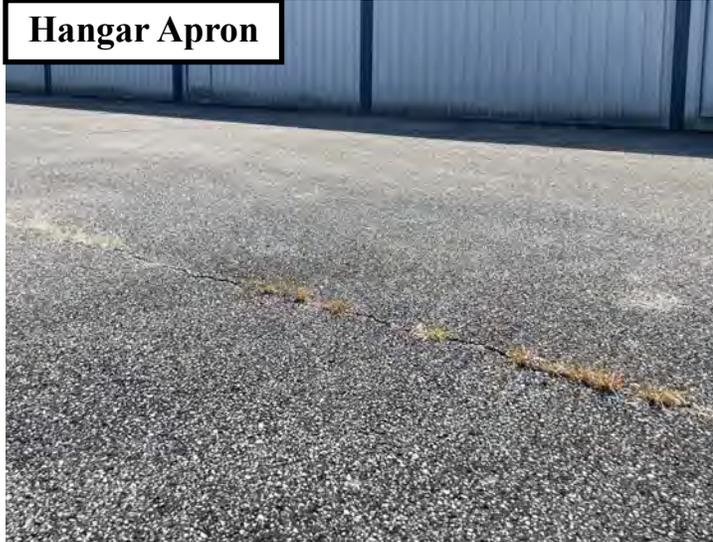
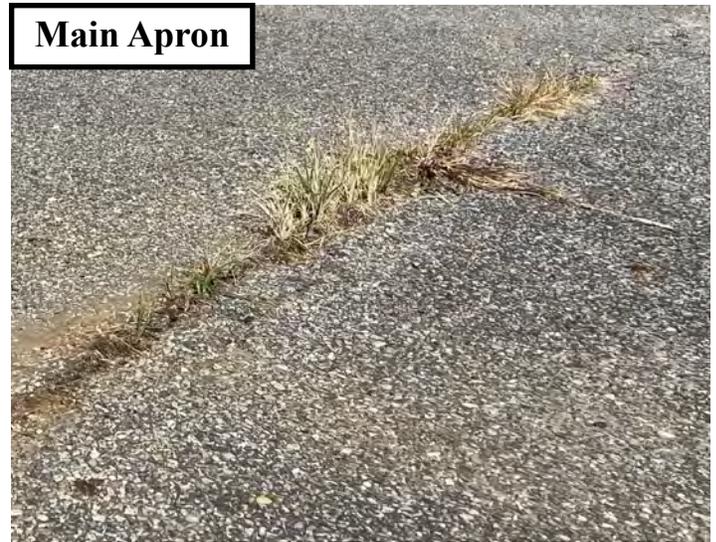
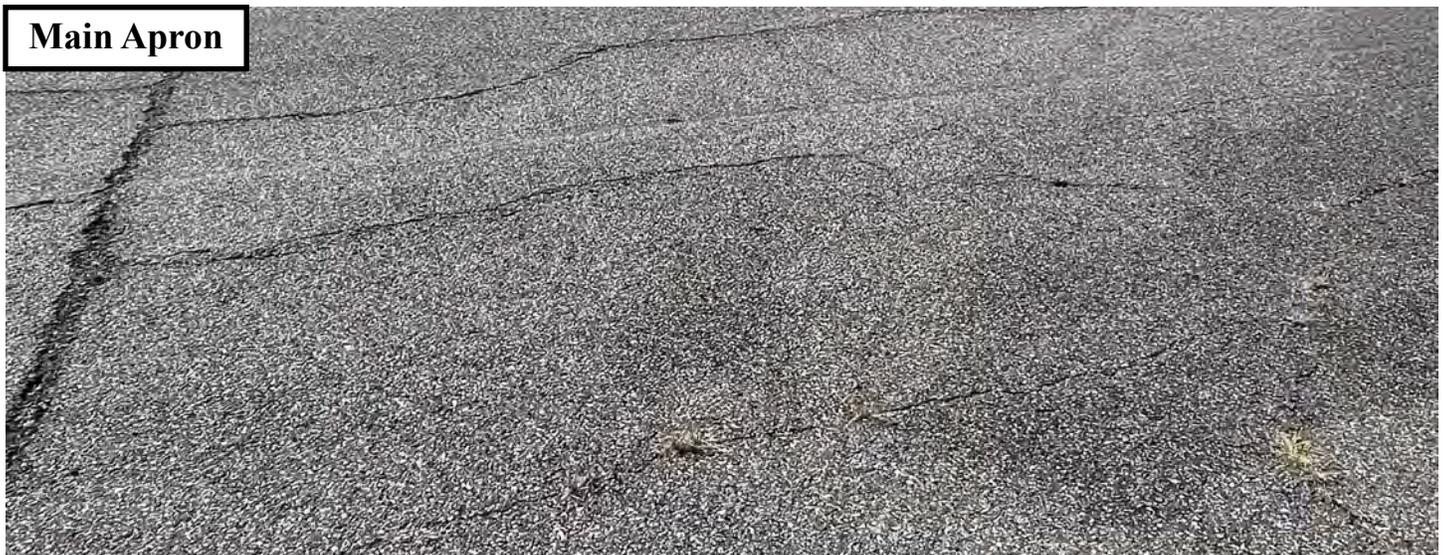
Runway, Taxiway and Apron Conditions—APRON

| Aeronautics Administrative Code | Inspection Results | Corrective Action | Notes |
|--|--|--|---|
| Runway, Taxiway and Apron Conditions Administrative Code 450-9-1-.12 (7) | <i>In Compliance</i> <i>Maintenance</i> | Please clear all vegetation from pavement cracks. | Some apron surfaces have vegetation growing through cracks. See page #13. |

MAINTENANCE: The apron surfaces range from **FAIR** to **POOR** condition. All apron surfaces exhibit cracking with varying degrees of severity. Vegetation is growing through these cracks in some areas. Please clear all vegetation from apron surface cracks.

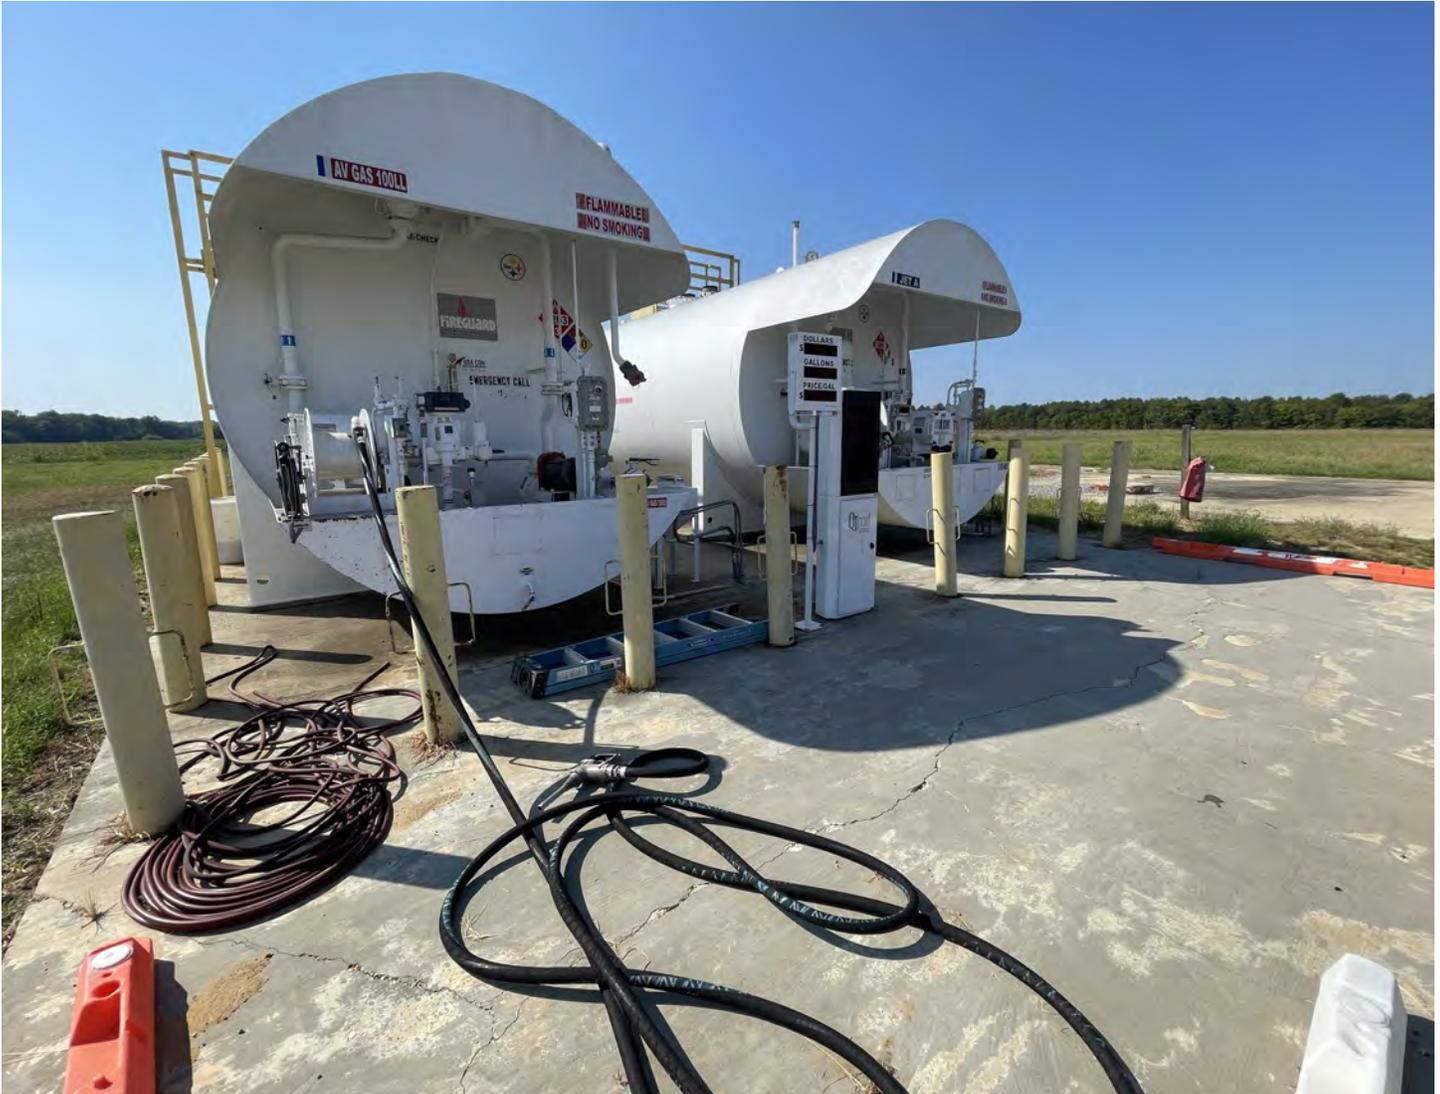
Fueling Area Requirements

VIOLATION: The fueling area **DOES NOT MEET** state licensing requirements. There were several deficiencies noted during inspection regarding the fueling infrastructure. These items are detailed on the following pages, please refer to them for more information.

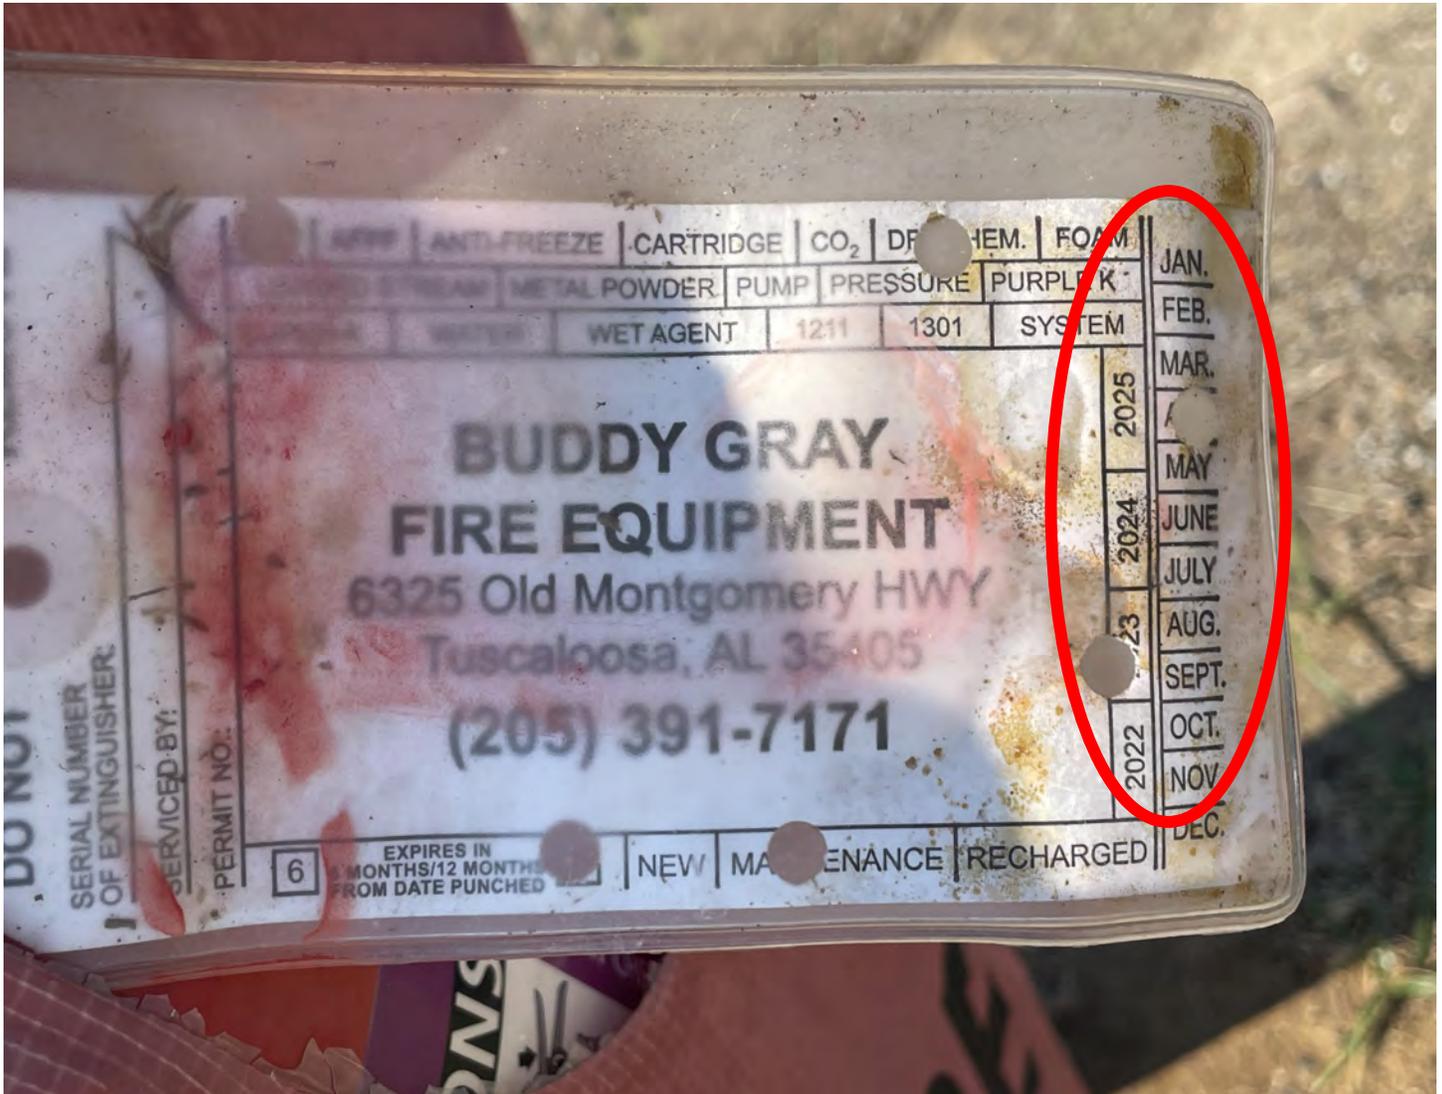
| Aeronautics Administrative Code | Inspection Results | Corrective Action | Notes |
|--|--|--|---|
| Fueling Area Requirements Administrative Code 450-9-1-.12 (8) | <i>Violation</i> | Please get fire extinguishers reinspected as soon as possible to verify their safe operational status. | The fire extinguishers at the fueling area are two years overdue for annual inspection. |

VIOLATION: The fire extinguishers located at the fueling area are two years overdue for annual inspection. Please get fire extinguishers reinspected as soon as possible to verify their safe operational status.
