Subject: Annual Inspection Report
Vaiden Field Airport (A08)

ANNUAL INSPECTION REPORT

**VAIDEN FIELD AIRPORT
MARION, ALABAMA**

Alabama Department of Transportation Aeronautics Bureau—Annual Airport Inspection Report

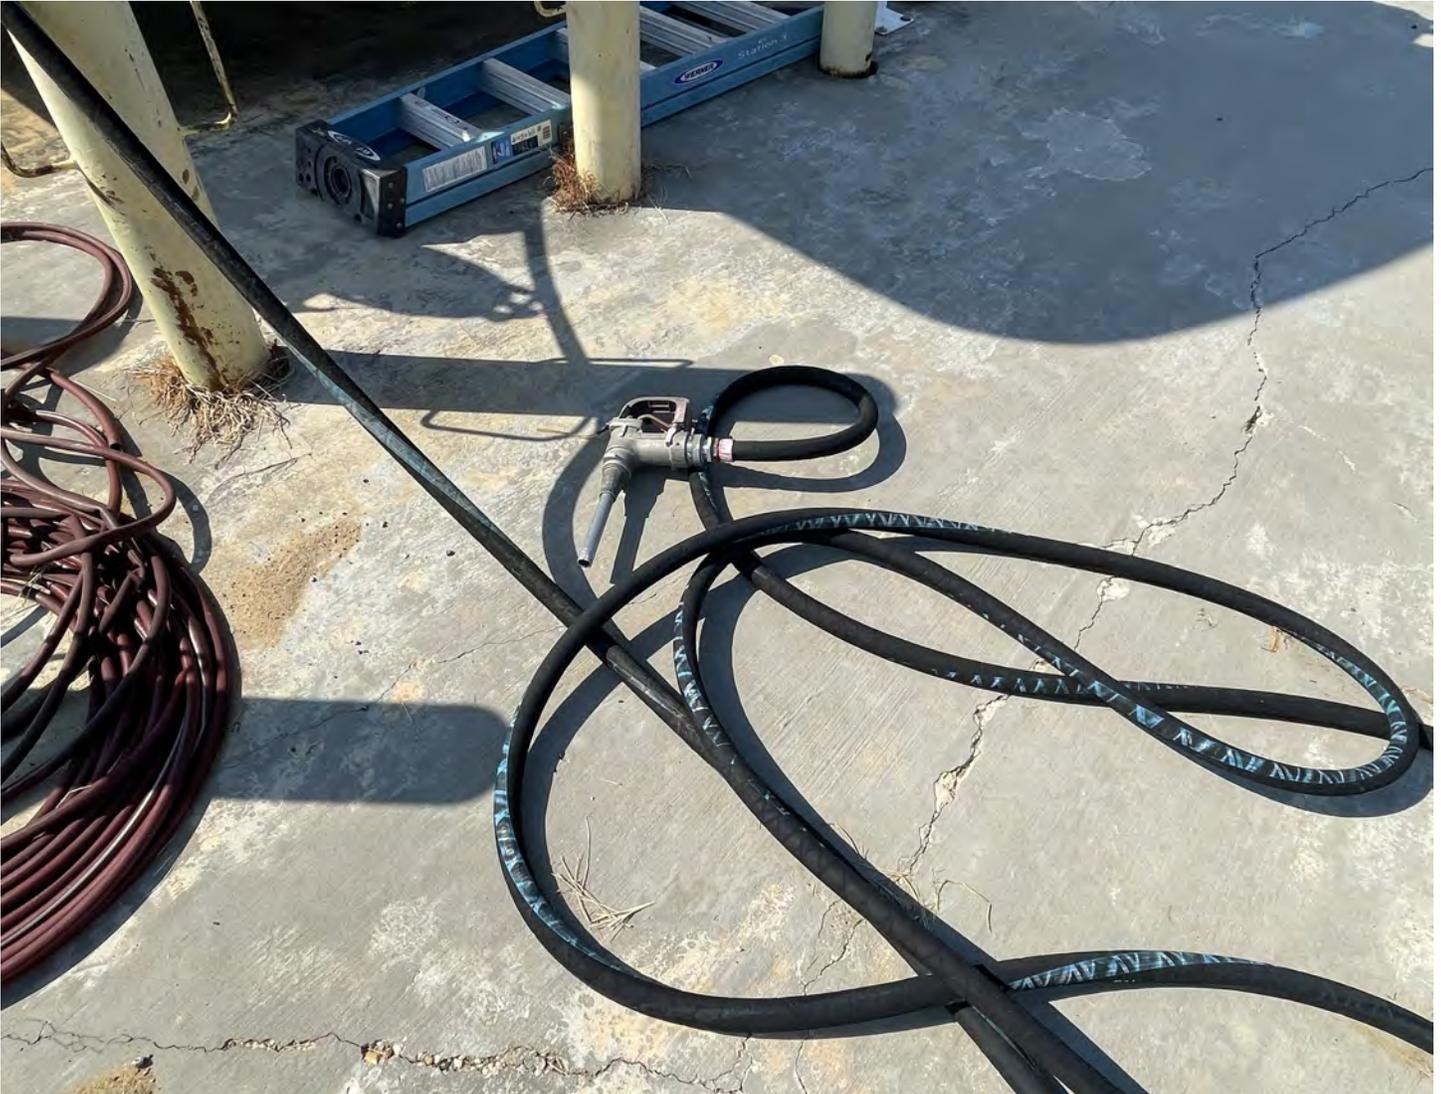
MAINTENANCE: The AvGas fuel transfer hose was improperly stored at the time of inspection. The fueling nozzle was uncapped and should be inspected as soon as possible to verify that no pollutants have breached its filter and entered the hose system.

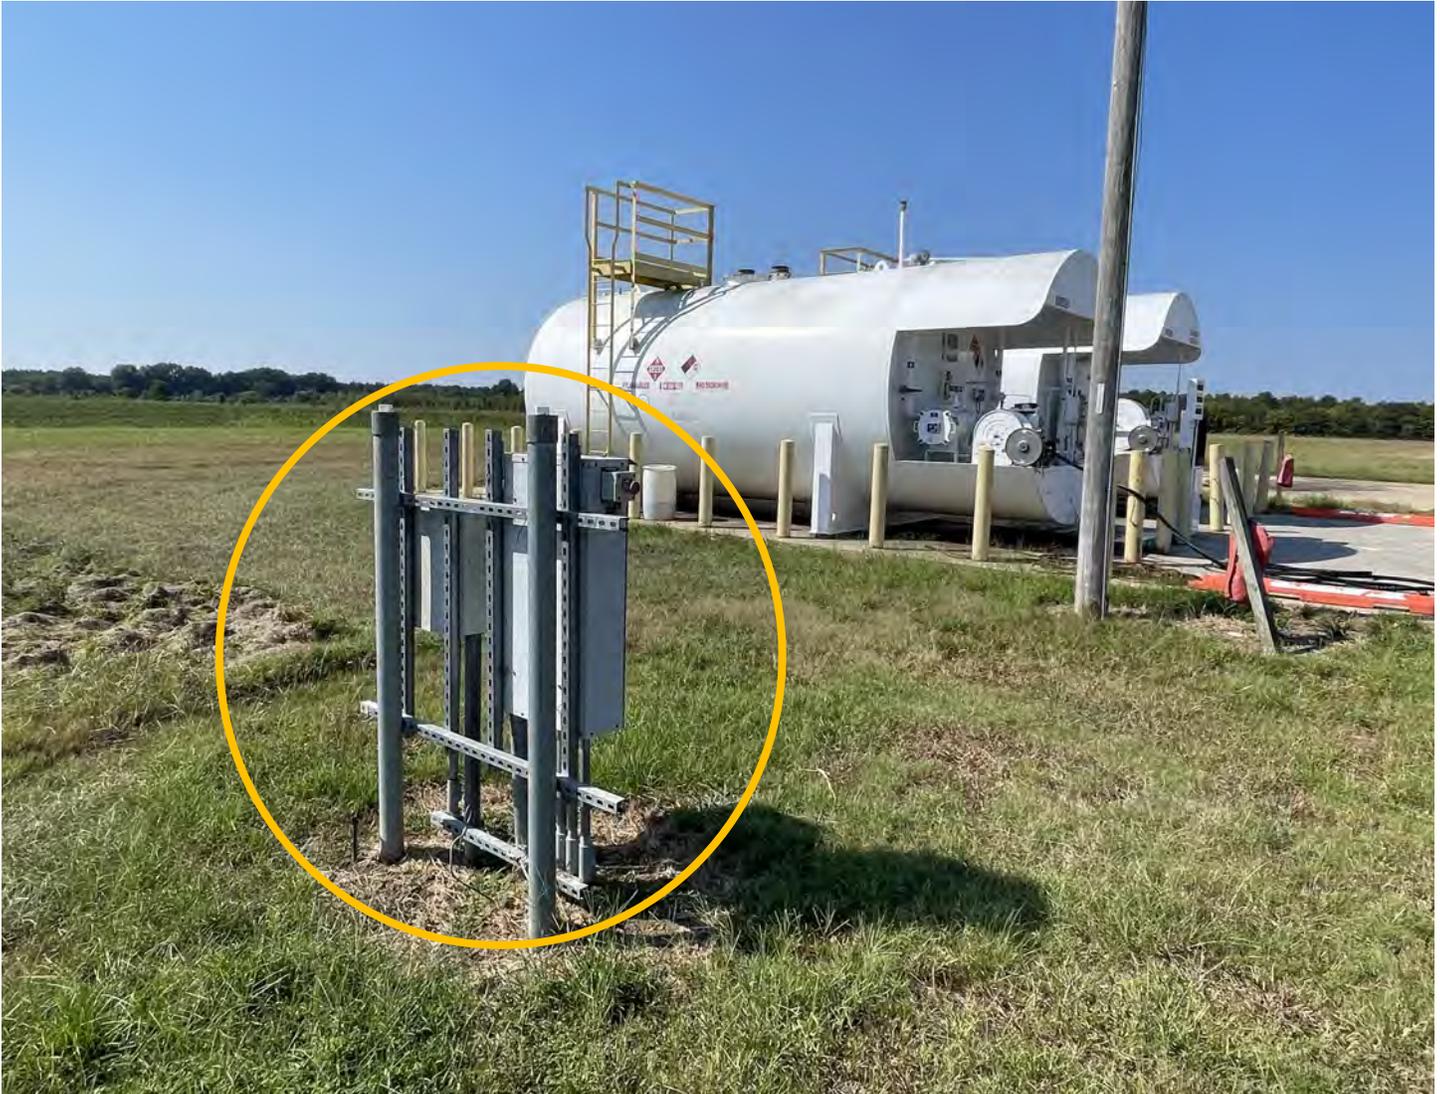
MAINTENANCE: The emergency fuel system shutoff switch, circled above, should be labeled more clearly so that any operators using the fuel system can find it and stop the pump in an emergency. Please add signs at the point-of-sale kiosk indicating the direction of the shutoff switch.

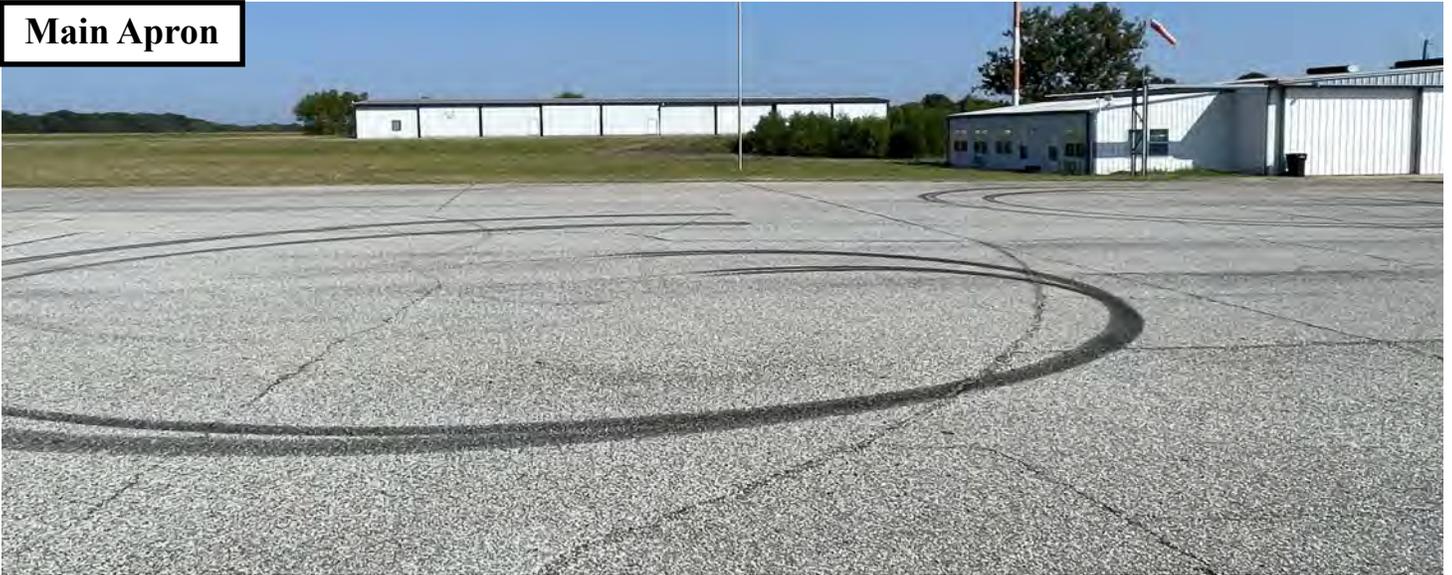
Main Apron

VIOLATION: There is evidence that unauthorized vehicles are accessing the airfield. Automobile and tractor tire marks were observed on several of the airfield pavement surfaces, including Runway 16/34. Please install barriers to entry or enact greater security measures to prevent unauthorized vehicles from accessing the airfield in the future. Talk with agriculture operators and inform them that traversing on airfield surfaces is prohibited.

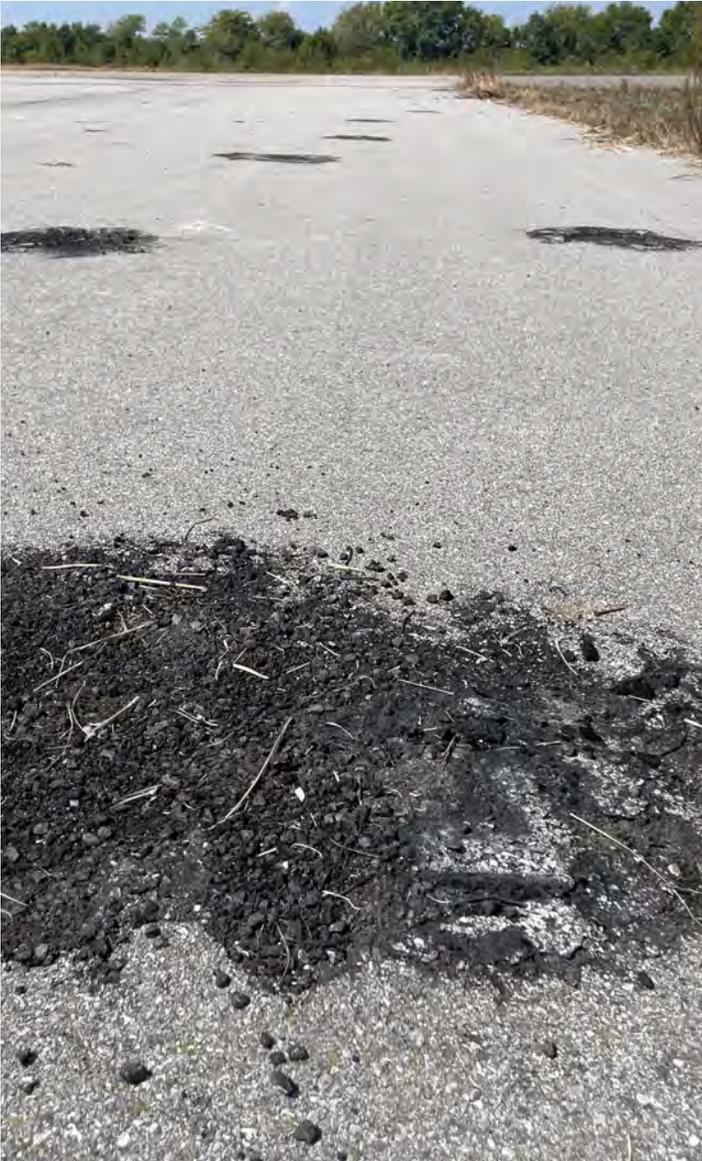
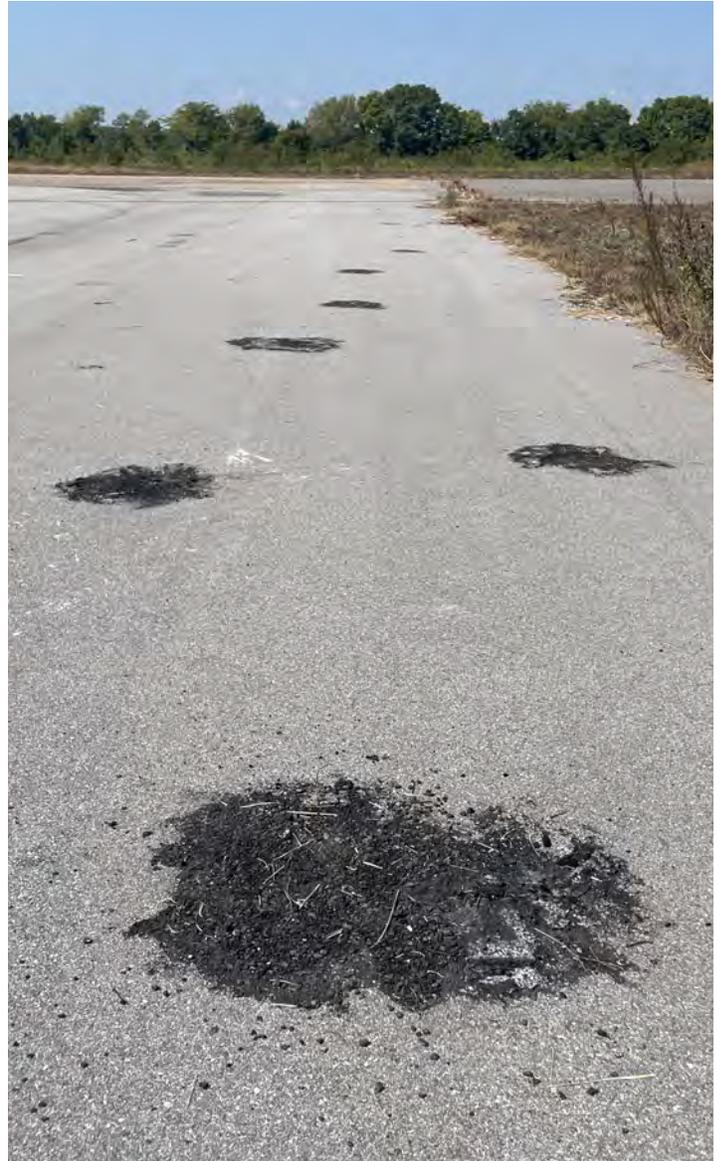
VIOLATION: Several wood burn piles were observed at the northern end of the parallel taxiway. These fires have damaged the pavement and several nails were found in the remains of the fires. Some of these nails have become embedded in the pavement and present a serious damage risk to aircraft. The fires were in close proximity to a dry field adjacent to the taxiway. Please install barriers to entry or enact greater security measures to prevent unauthorized persons from accessing the airfield in the future.

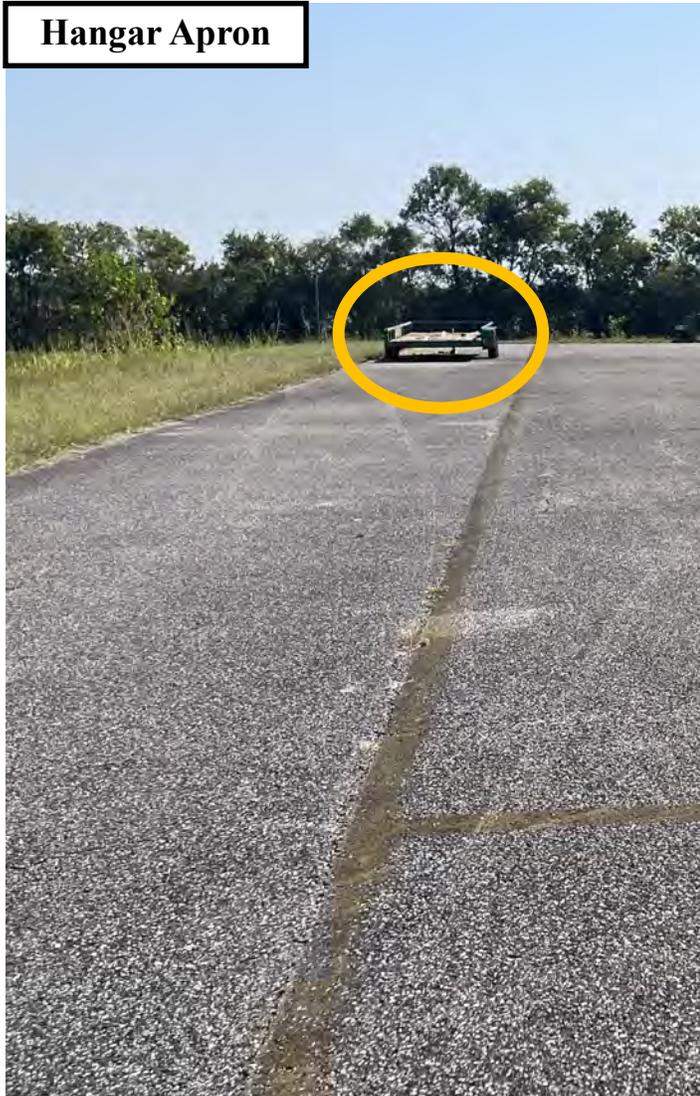
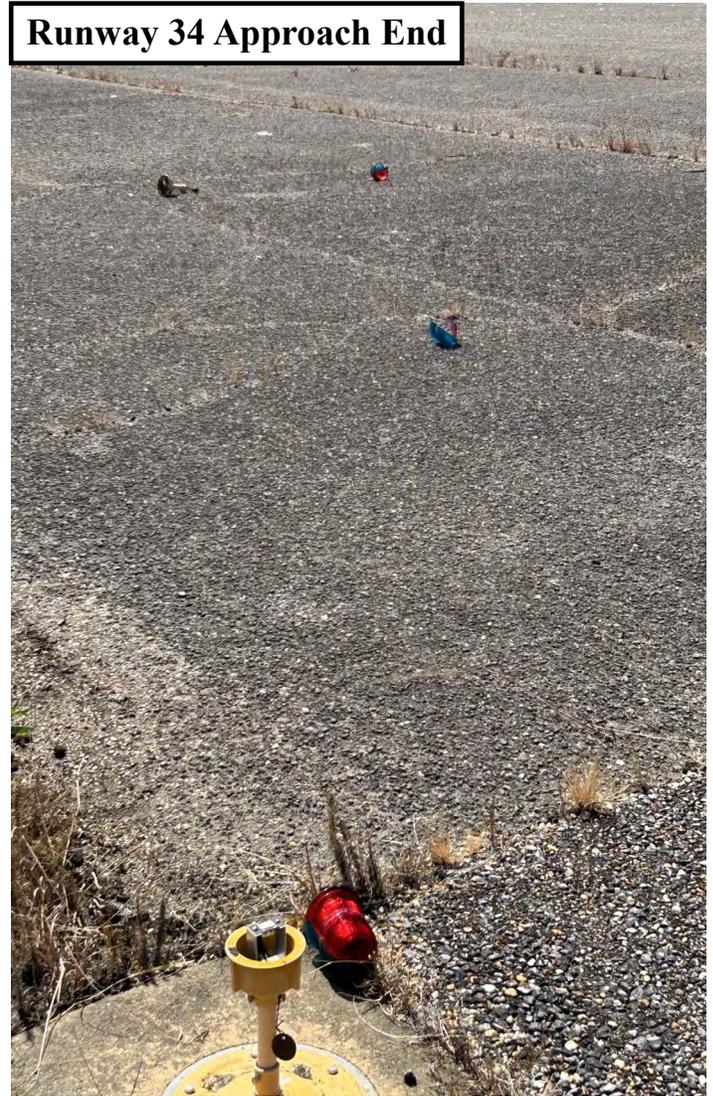
| Aeronautics Administrative Code | Inspection Results | Corrective Action | Notes |
|--|--|--|---|
| Additional Items | <i>In Compliance</i> <i>Maintenance</i> | Please relocate trailer. Clear the airfield of any broken light components to mitigate the FOD hazard they present. | There is a trailer on the hangar apron surface. Broken light globe pieces were found throughout the airfield. See page #20. |

MAINTENANCE: A trailer, circled above, was observed on the hangar apron. Please relocate this trailer from the apron surface. Additionally, several broken light globes and lighting components were observed on the airfield. These present a FOD hazard and should be cleared from the airfield as soon as possible.
