Subject: Annual Inspection Report
Vaiden Field Airport (A08)

ANNUAL INSPECTION REPORT

**VAIDEN FIELD AIRPORT
MARION, ALABAMA**

Alabama Department of Transportation Aeronautics Bureau—Annual Airport Inspection Report

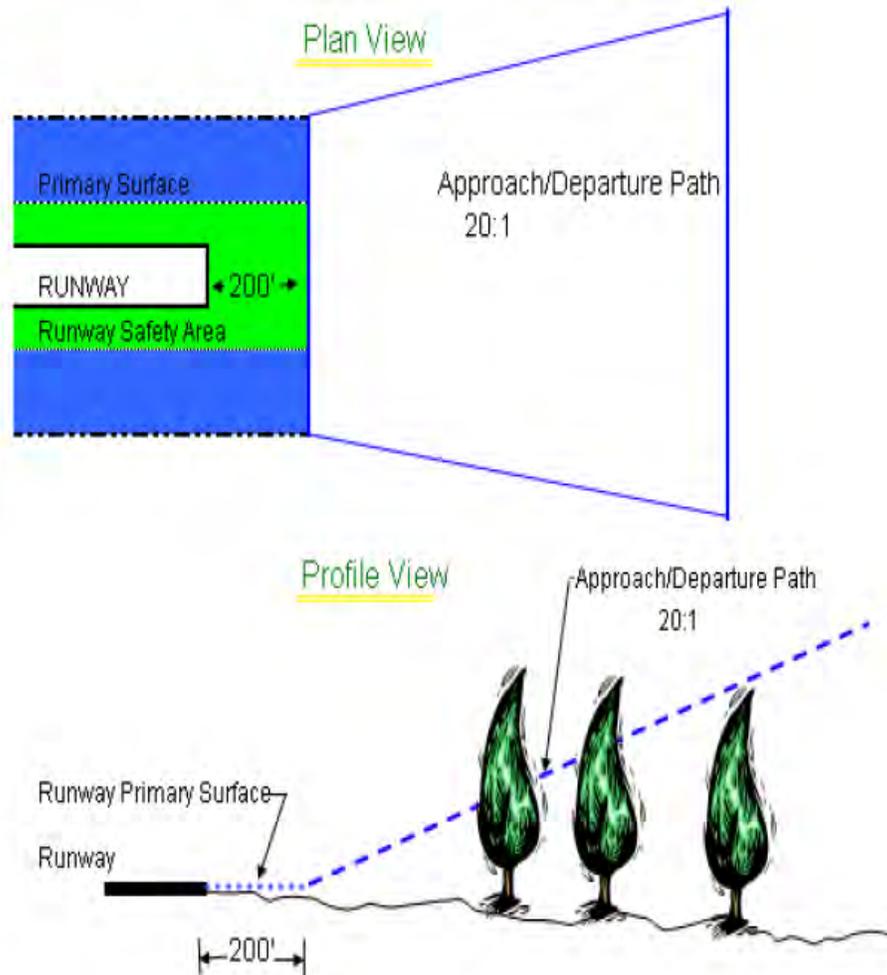
APPENDIX 2

VIOLATION: There were obstructions detected inside the ALDOT 20:1 Approach/Departure Path of Runway 16. These trees must be removed. **See Appendix #2.**

Vaiden Field Airport
Marion, AL
September 17, 2025
Runway 16 Obstruction Evaluation
